Prepared for Pure Property Management of Georgia

06/05/2025

659 Auburn Ave NE Ste 252

1 bed / 1 bath

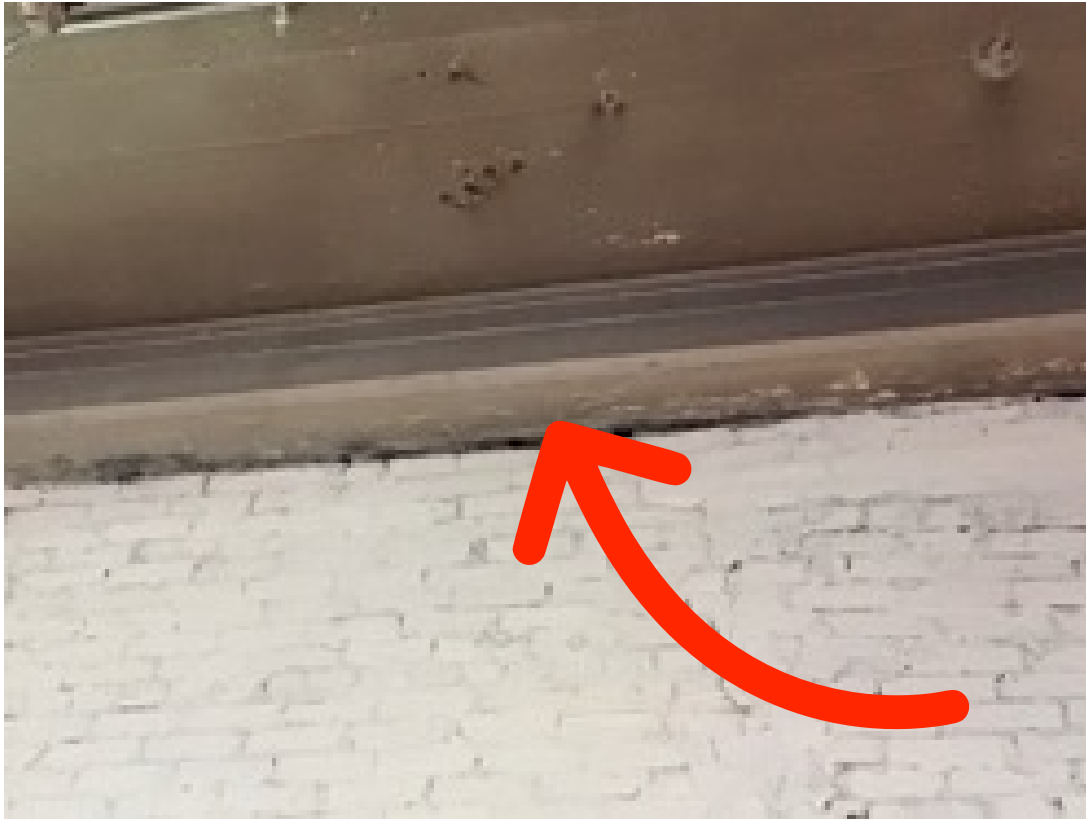
Bedroom 1

Ceiling

Major cracks in ceiling
Tenant explained that
there is sunlight being
able to get through the
cracks just above their
bedroom area

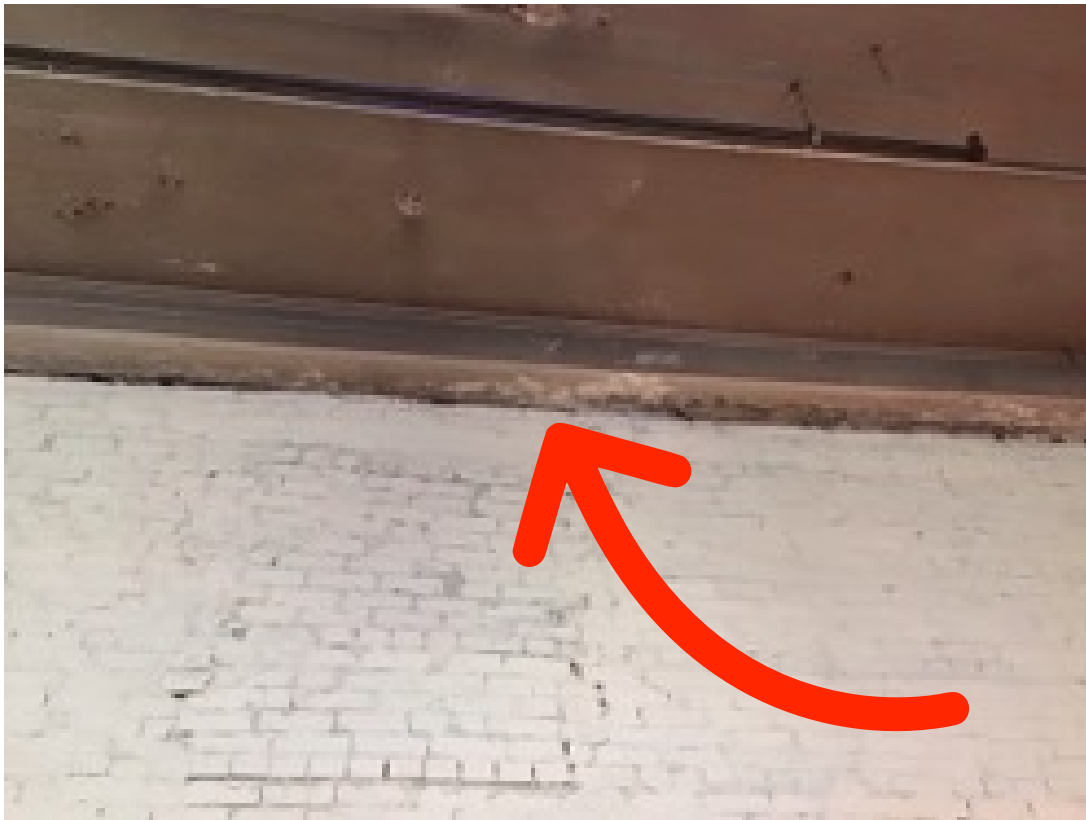
Bedroom 1

Ceiling

More of ceiling cracks
in the roofline

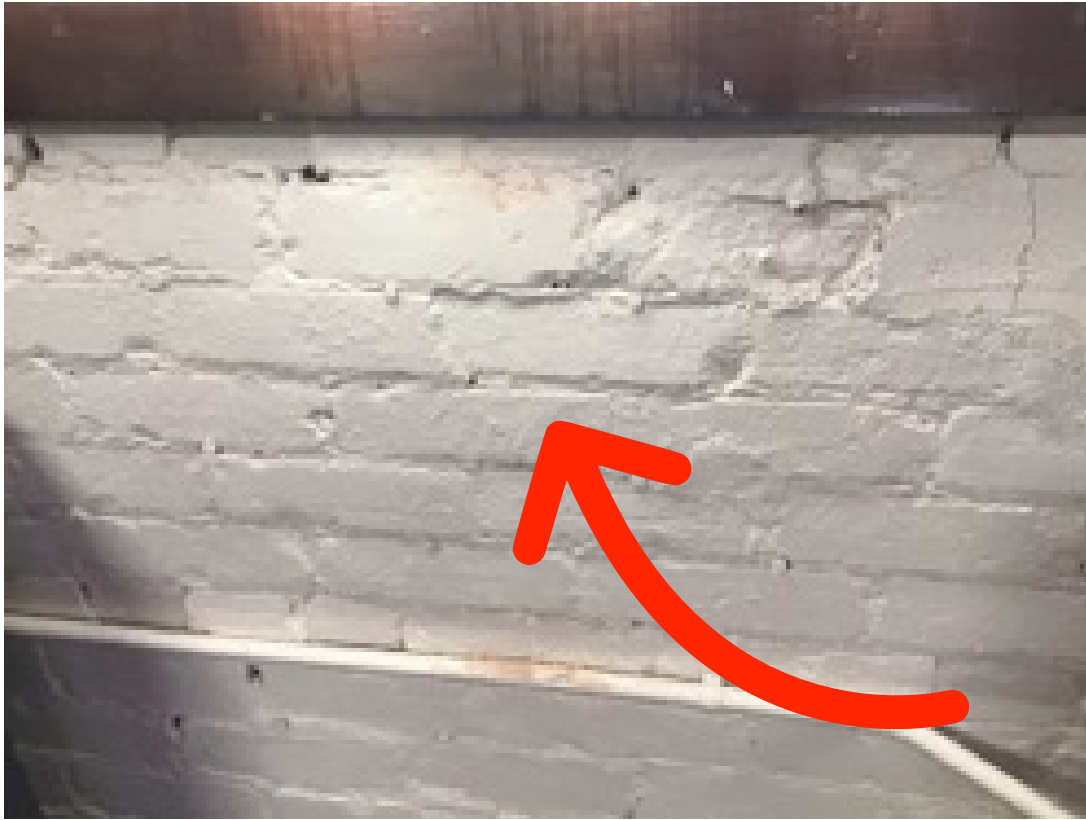
Bedroom 1

Windows

Window sill is damaged
Tenant noted that an
unusual dust has been
piling up just under the
window sill.

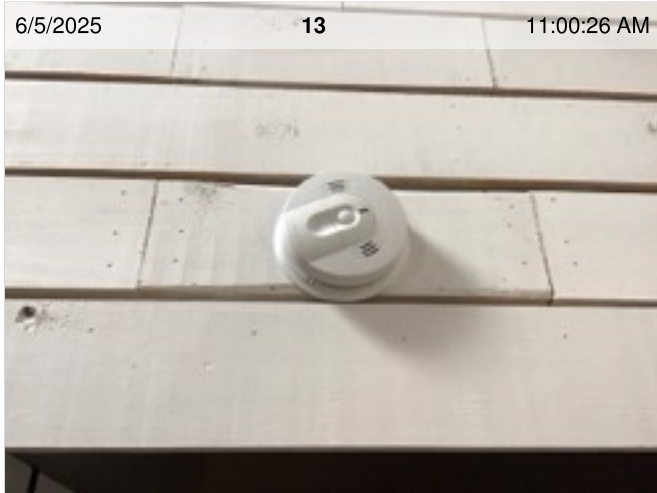
Wireless Smoke/CO Combo Smoke Alarm (mfd 6/2022) |
Smoke test: Passed | Alarm in place

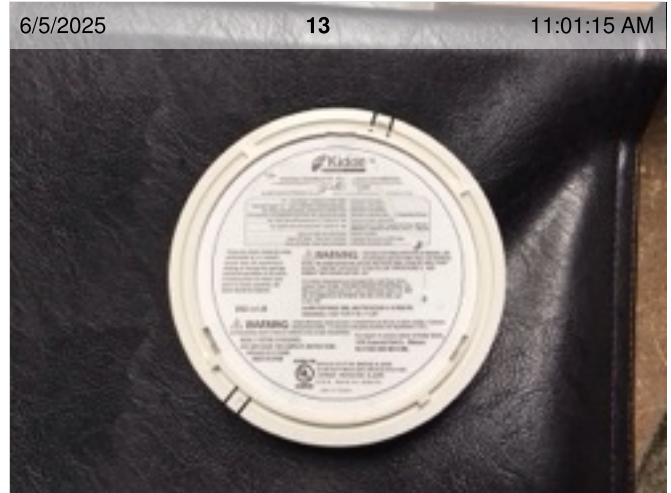
Wireless Smoke/CO Combo Smoke Alarm (mfd 6/2022) |
Smoke test: Passed | Close-up of printed manufacture date | 3
years old

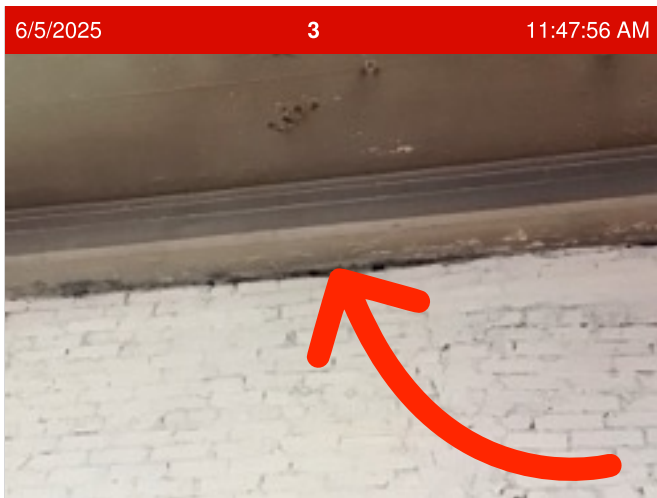
Ceiling | Major cracks in ceiling | Tenant explained that there is sunlight being able to get through the cracks just above their bedroom area

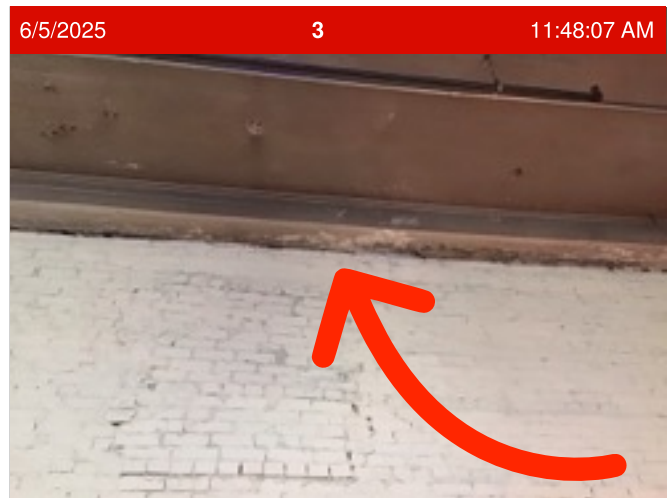
Ceiling | More of ceiling cracks in the roofline

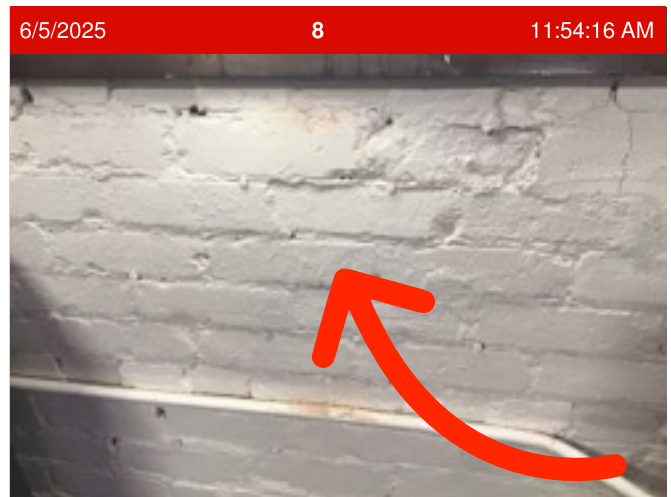
Windows | Window sill is damaged | Tenant noted that an unusual dust has been piling up just under the window sill.
